AUDIT REPORT

NEW CALEDONIA

AUDIT OF THE HIGH TEMPERATURE FORCED AIR (HTFA) TREATMENT PATHWAY FOR THE EXPORT OF APPROVED FRUIT FLY HOST COMMODITIES TO NEW ZEALAND

08 August 2013

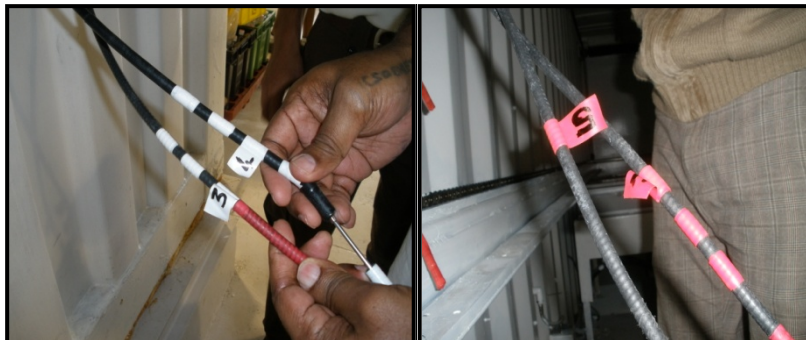
- 2.7 The operation manual documents that house probes are to be numbered as 1, 2, 3, 4, 5, 6, 7 and 8. However, during the audit, it was observed that this has been changed and numbering now has insulation tape strips placed around each probe wire depending on the probe number (e.g. two tape strips for probe 2 and etc). All the probes on the right side chamber were identified with white insulation tapes and the ones on the left chamber with red.

Numbering system to differentiate the house probes in the chamber (white tapes for the right chamber and red tapes for the left chamber). Numbers on the tapes refer to the probe numbers.

- 2.9 Noted and agreed with the non compliance.
- 3.0 While the tape strips currently used to identify the probes were maintained, the numbering as documented in the operational manual was re-implemented and probe numbers were written over the tapes pasted on the rubber wires holding each probe. Refer to Appendix B to view images.

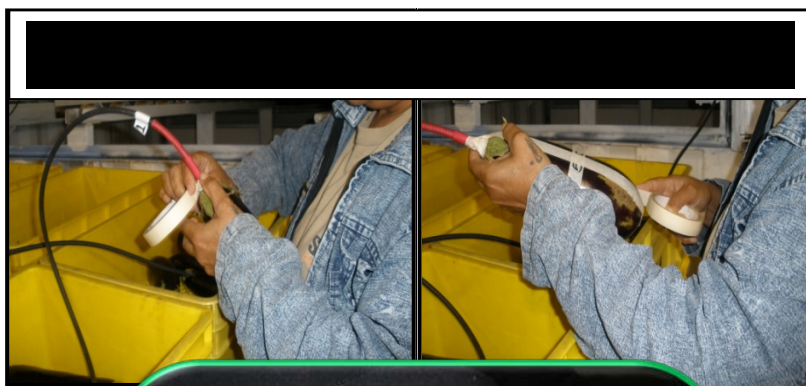
- 5.2 Probing by the biosecurity officers and treatment operators including the taping of the eggplants around the probing entry point to prevent heat loss was observed to be well implemented. Refer to appendix B for probing images.
- 5.3 Procedures for selection of probe fruits was well understood by the treatment operators and was well complied with during the time of the audit including its recording, documentations and inputting of information into the treatment computer for recording on the treatment printout.

Probing of eggplants and proper taping of probed points by treatment operators.

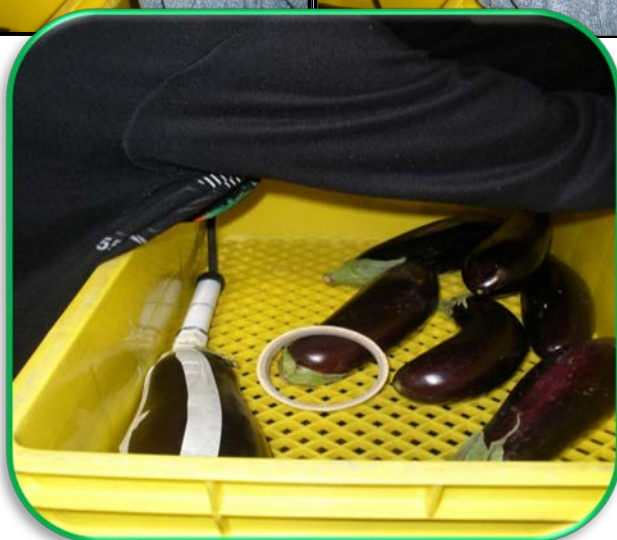
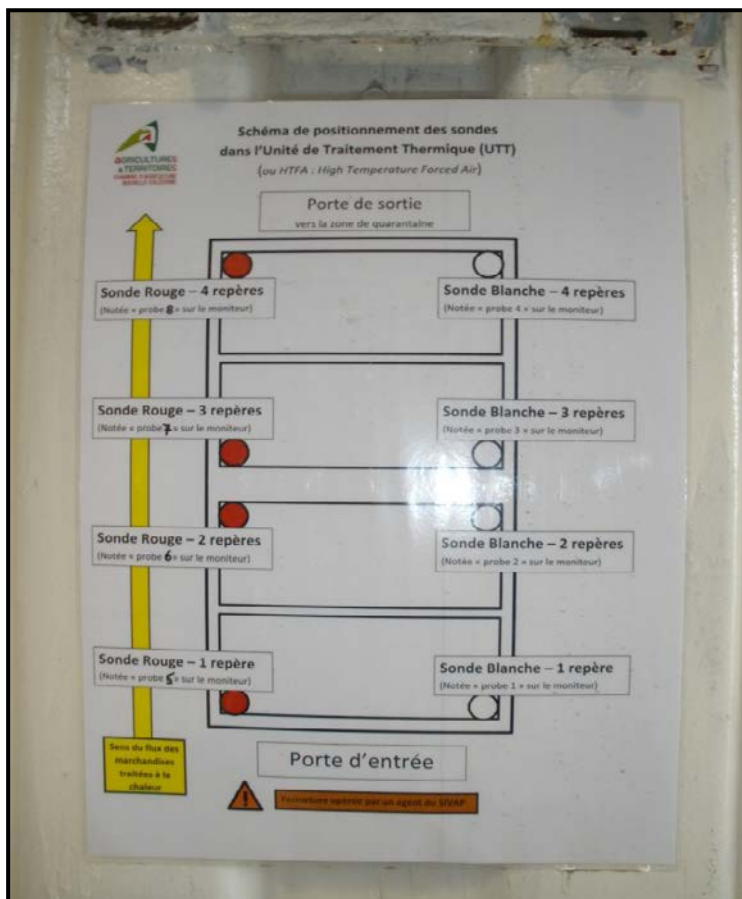
- 4.6 Repairing of floor fan (cut off-cut-in system) which was problematic during the 2011 audit. The fan is now in perfect operational condition.
- 4.7 Provision of procedures at different operation sites for reference e.g. computer treatment start-up procedures, cold spot map, fruit fly trapping system procedures, probing procedures, crates loading procedures etc.

Cold spot map posted in front of the chamber and under the main door for ease of reference.

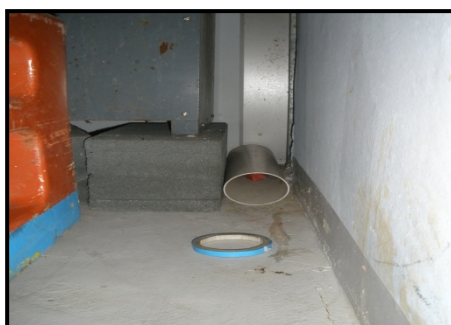
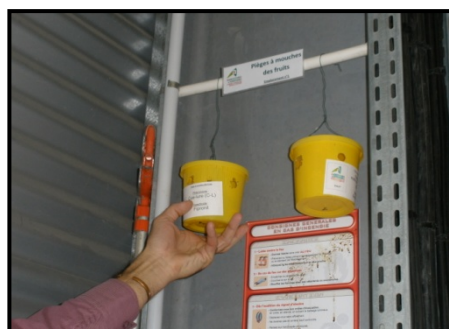
- 4.9 The certification for treatment operators was sighted and verified by MPI.
- 5.0 The fruit fly surveillance traps inside the facility were inspected. As an improvement from the 2011 audit, the traps now include both an attractant and an insecticide.

- 5.1 Rodent baits were also observed to be in place and well maintained. A hygiene map was posted on the wall to depict the location of the traps in the facility.

Rodent baits and fruit fly traps installed within the facility.

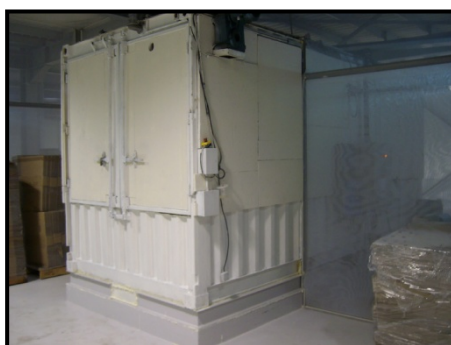
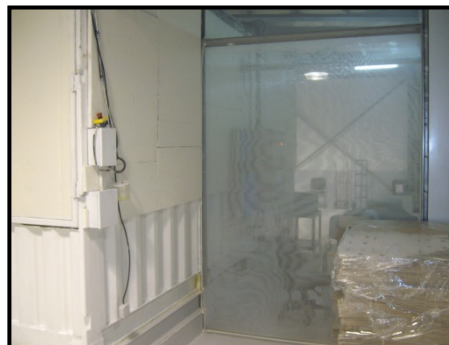
Treatment chamber with the netting screen separating the receiving/loading area and quarantine area of the facility.

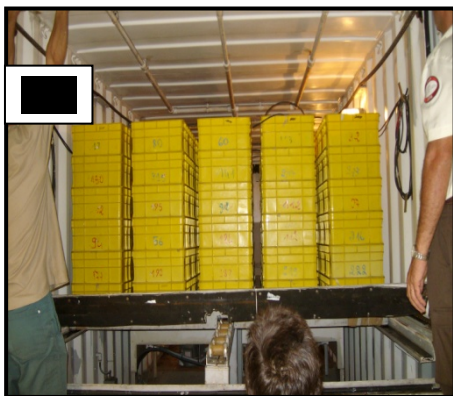
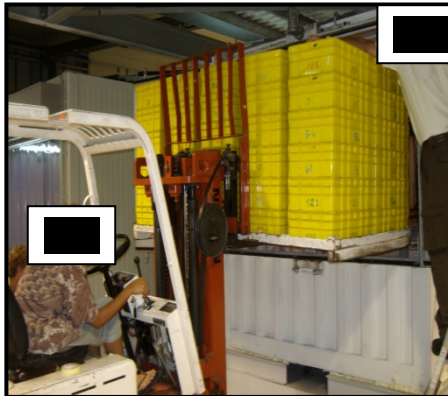
Loading of fruits for treatment.
