Flora and fauna survey for the Hydrilla eradication response 2016

Prepared for MPI

May 2016

NIWA CLIENT REPORT No: HAM2016-044
Report date: May 2016
NIWA Project: MPI16205

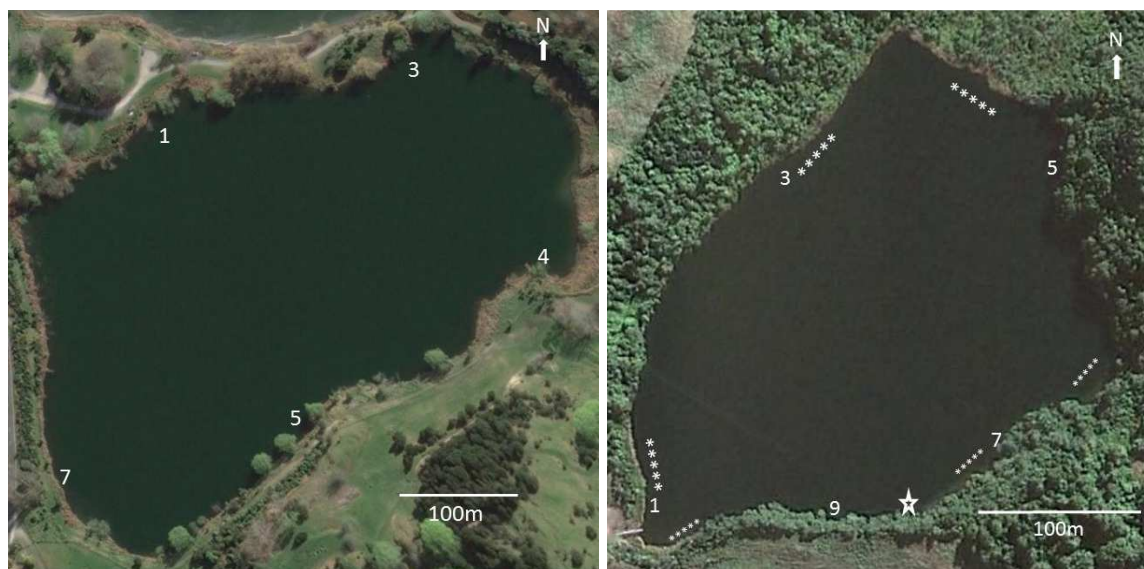
Figure 3: Lakes Waikōpiro (left) and Opouahi (right) showing survey and exclusion cages sites. Numbers refer to the survey sites for both lakes. On Lake Opouahi the large and small asterisks represent the large and small exclusion cages respectively and the star represents the tunnel cage.

Five sites in Lakes Waikōpiro and Opouahi were surveyed for aquatic vegetation (Figure 3). These were the same sites as those surveyed in autumn each year since 2008. The sites were located by GPS co-ordinates and photographed landmarks (Hofstra et al. 2008).

In Lake Opouahi SCUBA divers assessed the presence/absence of vegetation in 15 large and 15 small submerged exclusion cages (at a total of six sites with five cages at each) that were installed in February 2012 and a single tunnel cage that was installed in April 2015 (Figure 3). Photographs were taken of each cage to compare with previous images to assess charophyte emergence and growth, and to provide an estimate of localised changes in sediment level (if any), and hence the potential for burial of charophyte oospores. Temperature and light loggers that had been installed on the tunnel cage were removed and downloaded.

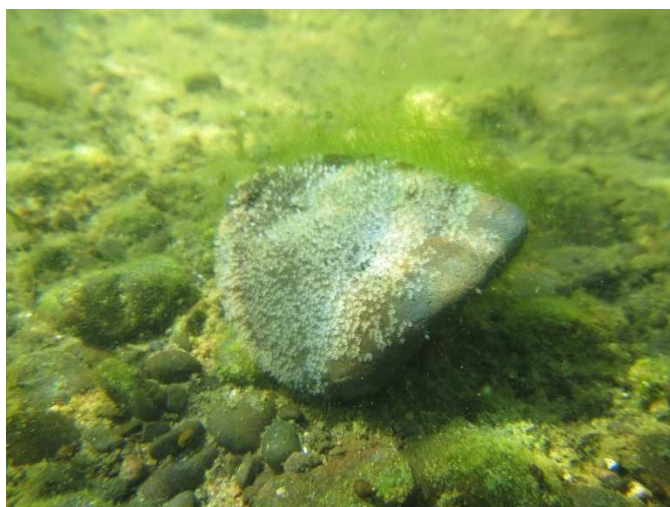
Figure 4: Bully eggs cover the surface of a small rock.

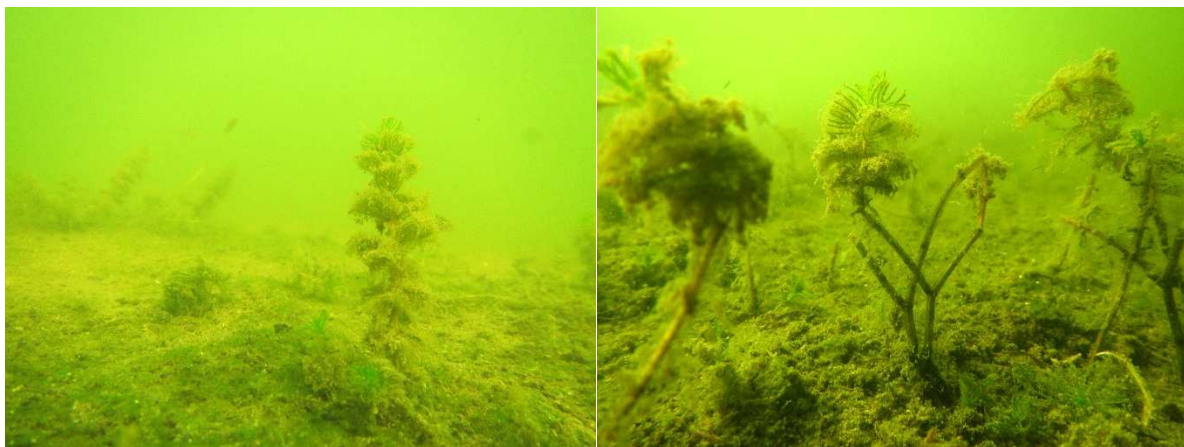
Figure 7: Native milfoil on the plateau. The images show plants of short stature with browsed shoot tips, and low abundance (Photos by M de Winton).

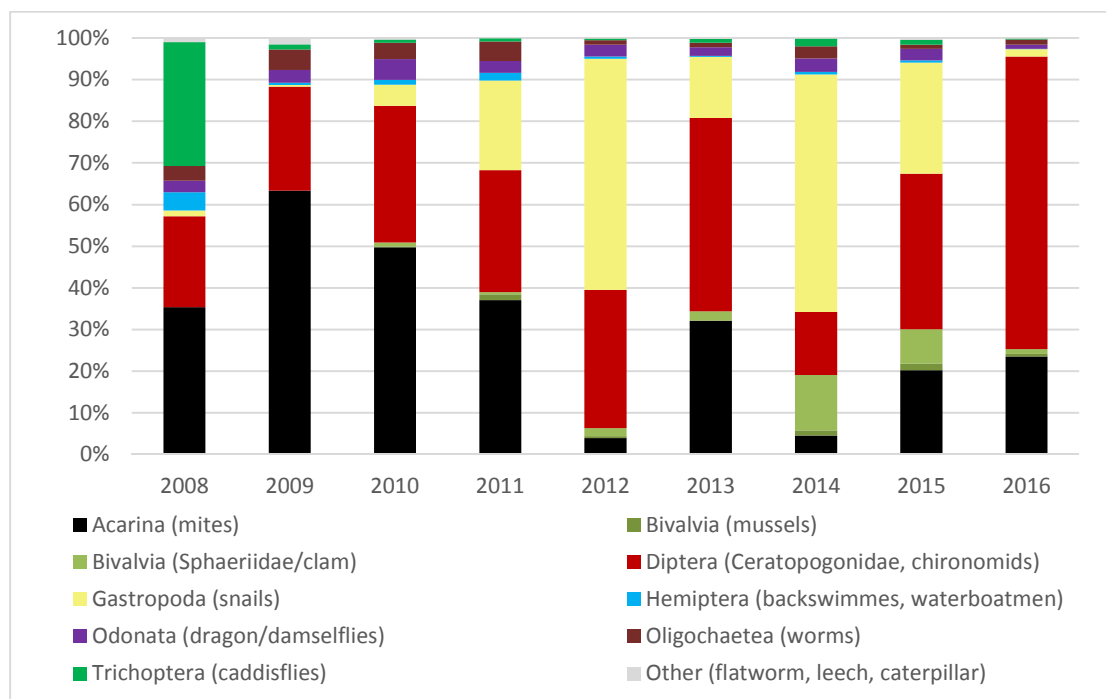
The total number of taxa recorded from Lake Tutira was within the range of values obtained before the hydrilla weed beds were removed by the grass carp (i.e., 2008 and 2009, Table 2), and the taxa recorded in this current survey were also present in previous surveys (Figure 9, Appendix A2).

Figure 9: The relative abundance of macroinvertebrate taxa from 2008 to 2016 autumn surveys.

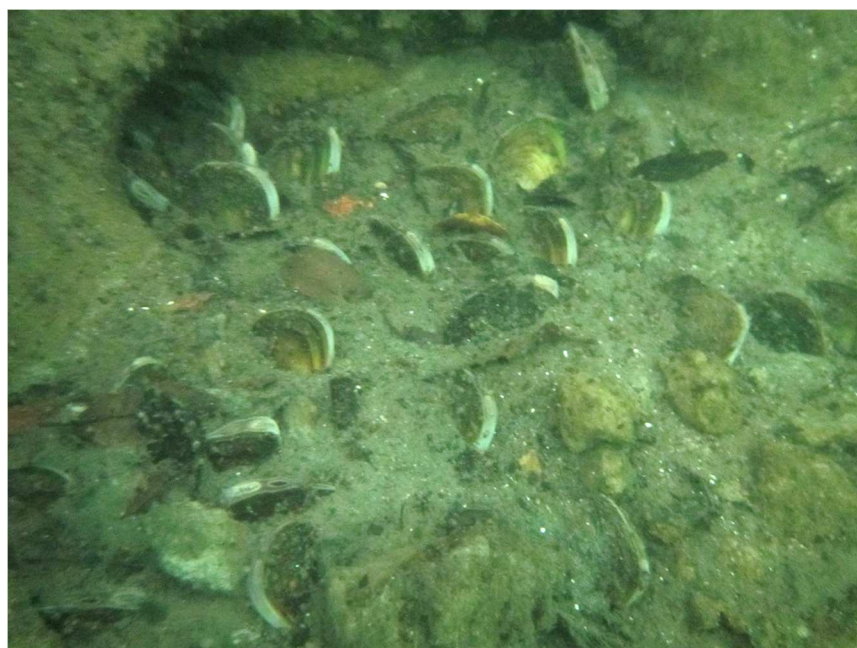
Information gathered by the SCUBA divers from Lake Opouahi is presented in Appendix C. In summary the divers reported reasonable water clarity with visibility of ca. 2m. Eel holes in the lake sediment were evident and one eel was observed. This year a single dense patch of mussels was found in Lake Opouahi at site 5 at ca. 2.6 m water depth. The patch had ca. 30 mussels with a further 10 mussels located nearby (Figure 11). The boat crew reported two dabchicks on the lake.

Figure 11: Mussels in Lake Opouahi. (Photo by A Taumoepeau).

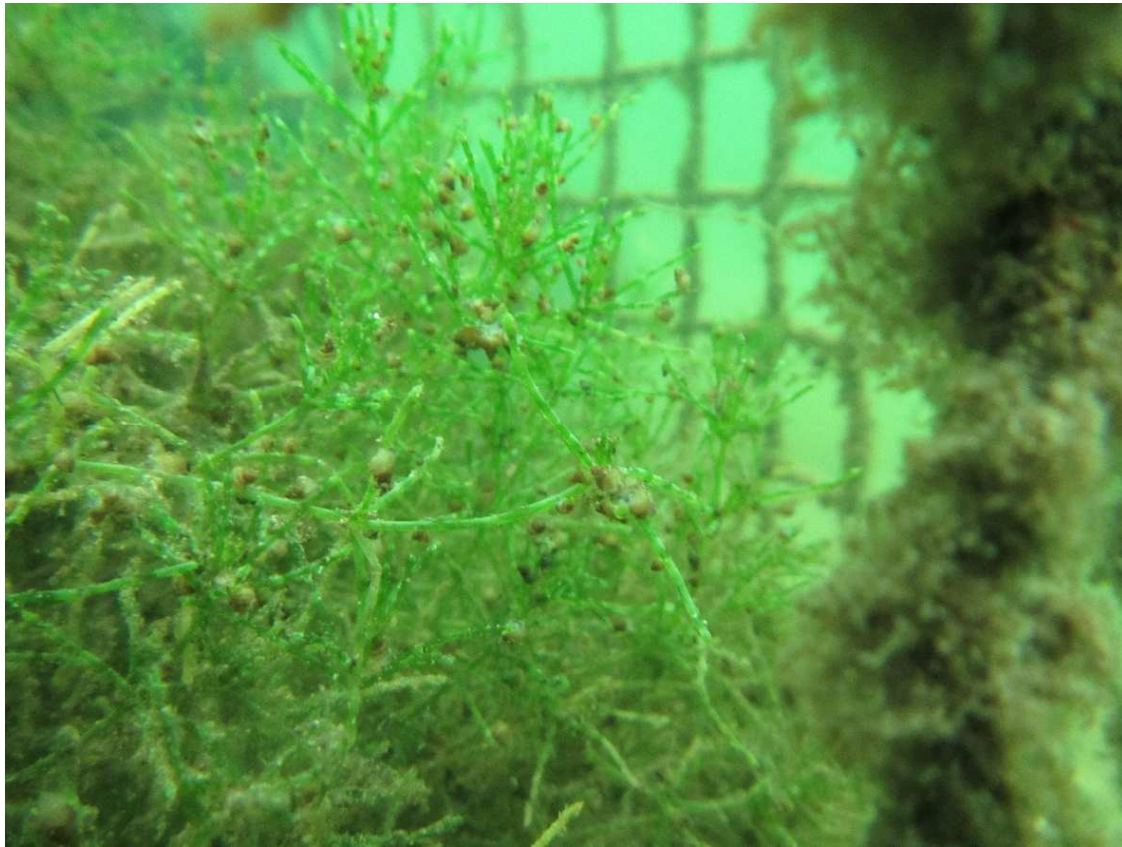
Figure 13: A view through the mesh of a large enclosure cage with *Chara australis* in Lake Opouahi.(Photo by A Taumoepeau).

It is recommended that the existing cages in Lake Opouahi are monitored in April 2017, and a set of five new cages or a tunnel cage is installed with a hessian benthic barrier.
