Hydrilla Monitoring Report 2017

Eradication response

Prepared for MPI

NIWA CLIENT REPORT No: 2017383HN
Report date: November 2017
NIWA Project: MPI17204

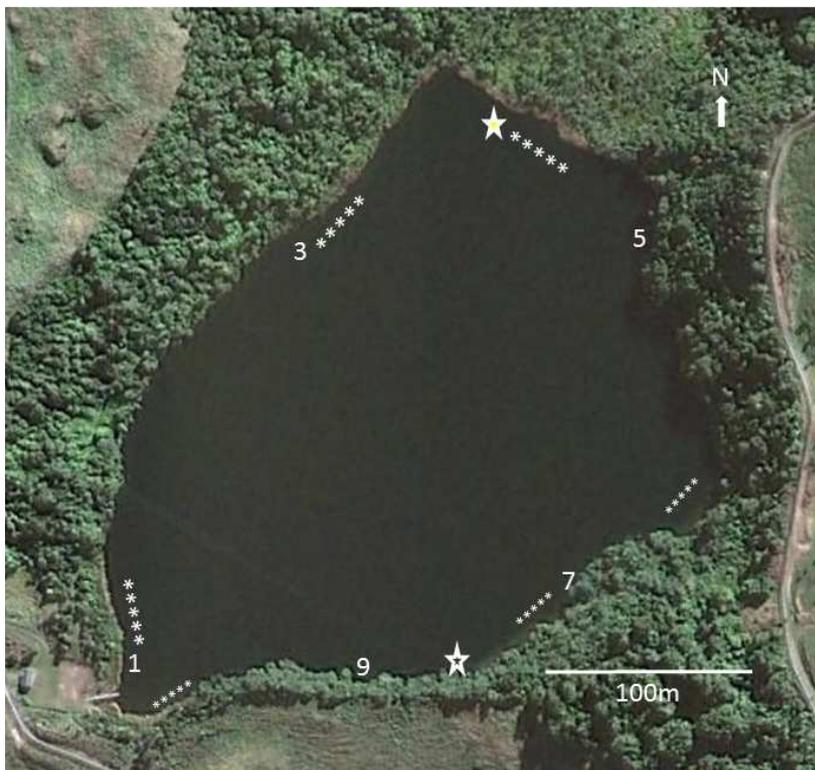
Figure 2-3: Lake Opouahi showing the exclusion cage sites. Numbers refer to the baseline survey sites. The large and small asterisks represent the large and small exclusion cages respectively and the stars represents the tunnel cages.

A tunnel cage (ca 1m wide by 2.6m long) was made on shore from semi rigid plastic mesh (green safety fencing with 50mm by 50mm mesh). These were the same materials and methods used to make the cages that were previously installed in the lake (Hofstra and Clayton 2012, Hofstra 2015). Hessian (18 oz, RJ Reid) was cut to fit inside the tunnel cage. SCUBA divers laid the hessian first and then, installed the cage over the hessian by lodging it into the sediment and securing with solid plastic warratah posts, at a depth of 2 to 3m at the north end of the lake, adjacent to (northeast of) the large cages (Figure 2-3).

Plants were present in two of the large cages at the site closest to the jetty (Figure 2-3). The plants were charophytes (ca. 33% cover, most likely *Nitella* sp. aff. *cristata* (Figure 3-7) determined in 2016 at this site) in one cage and *Potamogeton crispus* in the other cage. No plants were observed in the other cages along the west and north shores of the lake, nor in the tunnel cage on the southern shore. In contrast, during the last two monitoring events (2015 and 2016) the amount of charophyte vegetation had increased to 100% cover in one cage at the north end of the lake. The continued growth of those plants supported the hypothesis that once a threshold density or size is reached the plants will persist, as opposed to small plants or germlings that appear to be highly susceptible to disturbance and a large portion of germlings have not survived longer than a year (Hofstra 2014, 2015). The single cage with charophytes adjacent to the jetty, still supports this hypothesis, as these plants have increased in area from 2016. In addition, it is possible that the vegetated cage at the northern site was one of the two cages that were not located under the low visibility conditions.

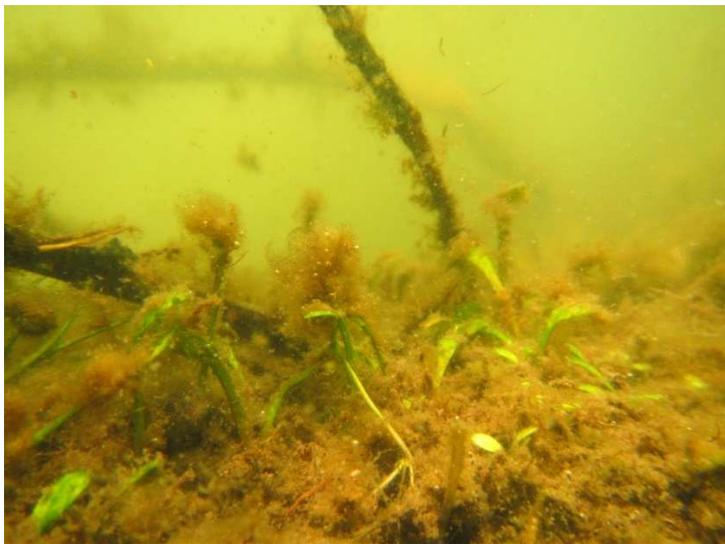
Figure 3-1: Low growing native plants in shallow water in Lake Tutira. (Photo by M de Winton).

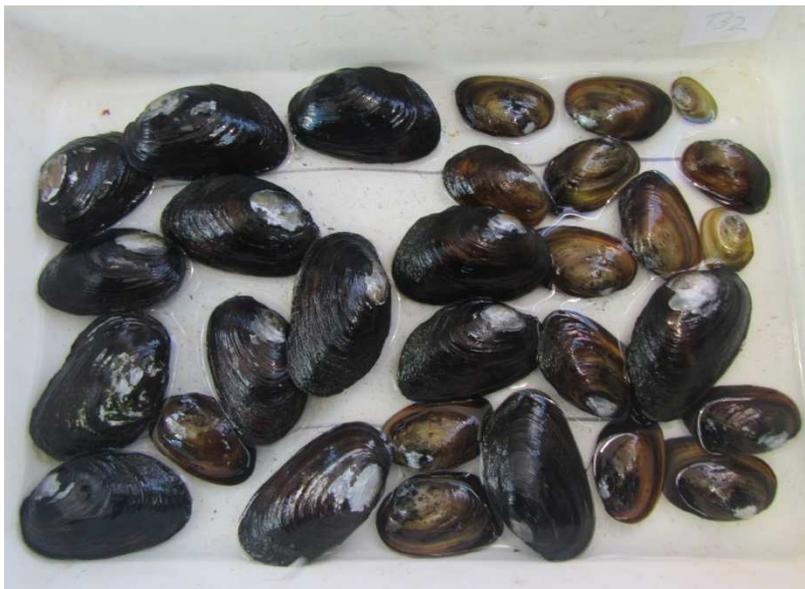
Figure 3-5: Mussels sampled from the causeway (T32). The causeway was the site from which the median number of mussels was collected. The smallest mussel seen in this photo was 26mm long (Photo by Aleki Taumoepau).

Initial information on mussel absence, presence or abundance was recorded by divers alongside the vegetation data in years 2008 to 2010. When juvenile mussels were first noted in the lake, amongst the macroinvertebrate samples, a decision was made to record the mussel data gathered by that method as well as the diver observations. Hence mussel numbers and lengths have been recorded from 2011 and 2012, respectively. During the present survey juvenile or young mussels (less than 30mm in length) were recorded from three sites, including the causeway site (T32, Figure 3-5), a site on the west (T50) and on the east shores of the lake (T22).

The causeway was the site from which the median number of mussels was collected, and mussels from most size classes (Figure 3-6). While young mussels were recorded from the lake in 2017, the distribution of mussels shows there are greater numbers of large older mussels, as illustrated by the site T32 sample, compared with 2012 when mussels under 10mm and those in the 61-70mm size class were equally abundant (Figure 3-6).

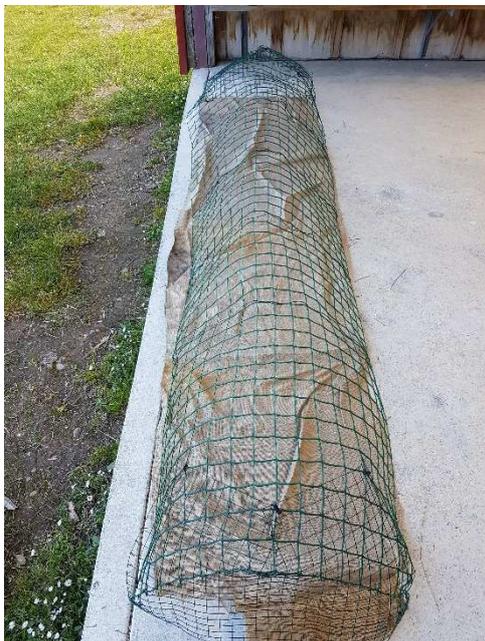
Figure 3-8: Construction of the exclusion cage with the benthic barrier.

To improve substrate stability, and potentially improve local habitat for charophyte germlings whilst excluding grass carp, a new tunnel cage, with a hessian benthic barrier (Figure 3-8), was installed at the north end of the lake. This location was chosen, in part because of the past success reported from a cage at this site, and because the site was considered a minimal risk for the presence of hydrilla tubers (based on assessments prior to the release of grass carp) (Hofstra 2016).

As with the existing cages, the new cage with the benthic barrier will require monitoring for charophyte response, and to ensure that (in the unlikely event of regeneration from tubers) rapid hydrilla plant removal is possible.

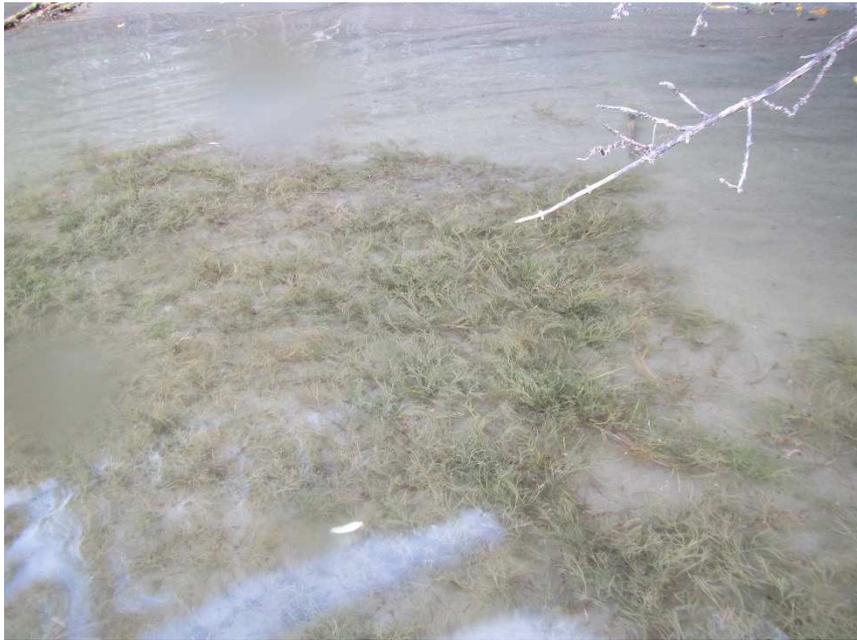
Figure 3-9: *Ranunculus trichophyllus* in shallow water in Lake Opouahi (photo by M de Winton).

The only submerged macrophyte that was seen in the lake outside of the grass carp exclusion cages was *Ranunculus trichophyllus*. *Ranunculus trichophyllus* is considered a less palatable or non-desirable species for grass carp (Rowe and Schipper 1985) and plants show little evidence of having been browsed. This species was observed in patches along the southern shore line (Figure 3-9) and at the outflow. Amongst the *R. trichophyllus* at the outflow there were also a few stems of *Elodea canadensis* (Figure 3-10). *Elodea canadensis* is an introduced submerged weed in New Zealand, that has been recorded previously from Lake Opouahi. No *E. canadensis* has been recorded in the main body of the lake however, there are isolated plants by the bridge over the outflow, and there is currently a larger patch of *E. canadensis* in the outflow adjacent to the pest proof fence (Figure 3-10). The patch is small enough that physical removal is possible. If the plants were excavated, they should be allowed to dry out and compost on the adjacent shore within the pest proof fence. Composting the plants on site will ensure there is no risk of transferring aquatic life to another site. Any equipment, such as waders or rakes used in the process of excavating the *E. canadensis* should be thoroughly decontaminated (e.g., dried out, washed in salt water) before being used elsewhere.

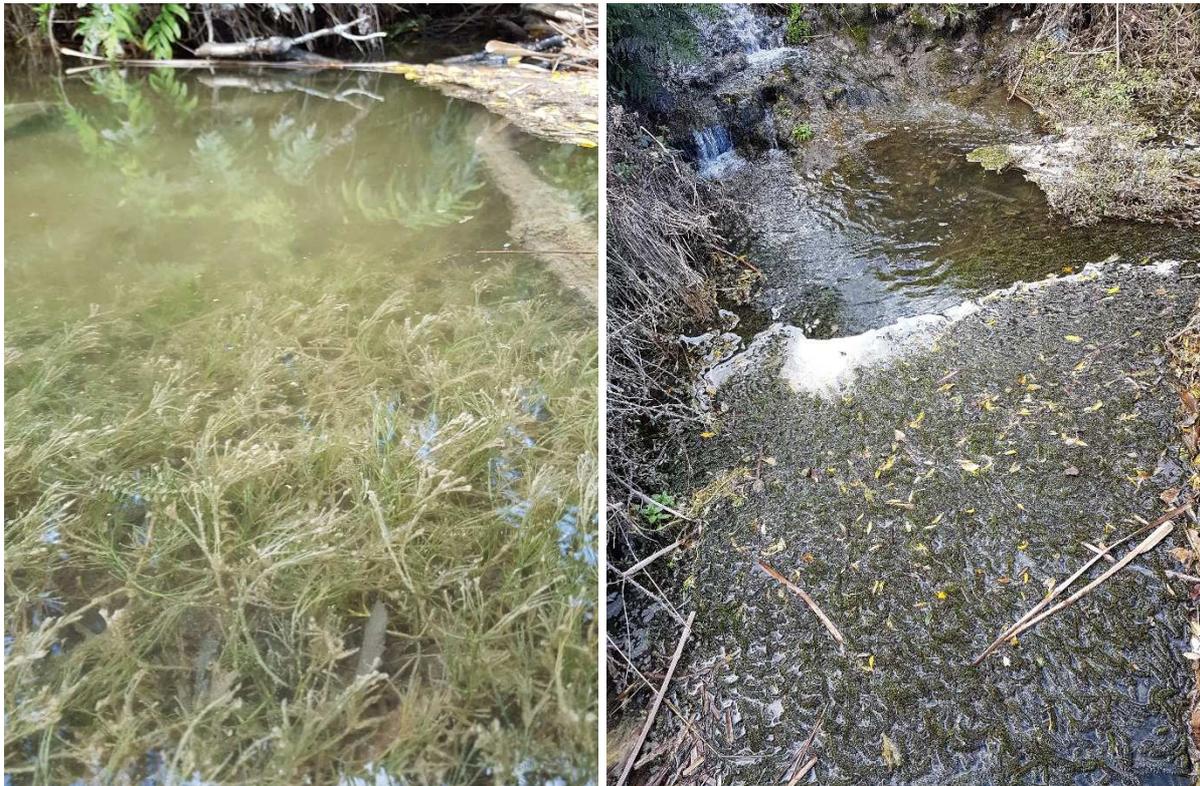
Figure 3-10: Submerged vegetation at the outflow. *Ranunculus trichophyllus* with small shoots of *Elodea canadensis* (left) and *Elodea canadensis* adjacent to the pest proof fence (right).
